Irene's Cement Creek  
 San Juan Range  
 CO  
 Elevation: 12010 ft  
 Aspect: NE  
 Specifics:

Bill Nalli  
 03/03/2020 - 12:00pm  
 Co-ord: 37.83338N, -107.69686W  
 Slope Angle: 34°  
 Wind Loading: yes

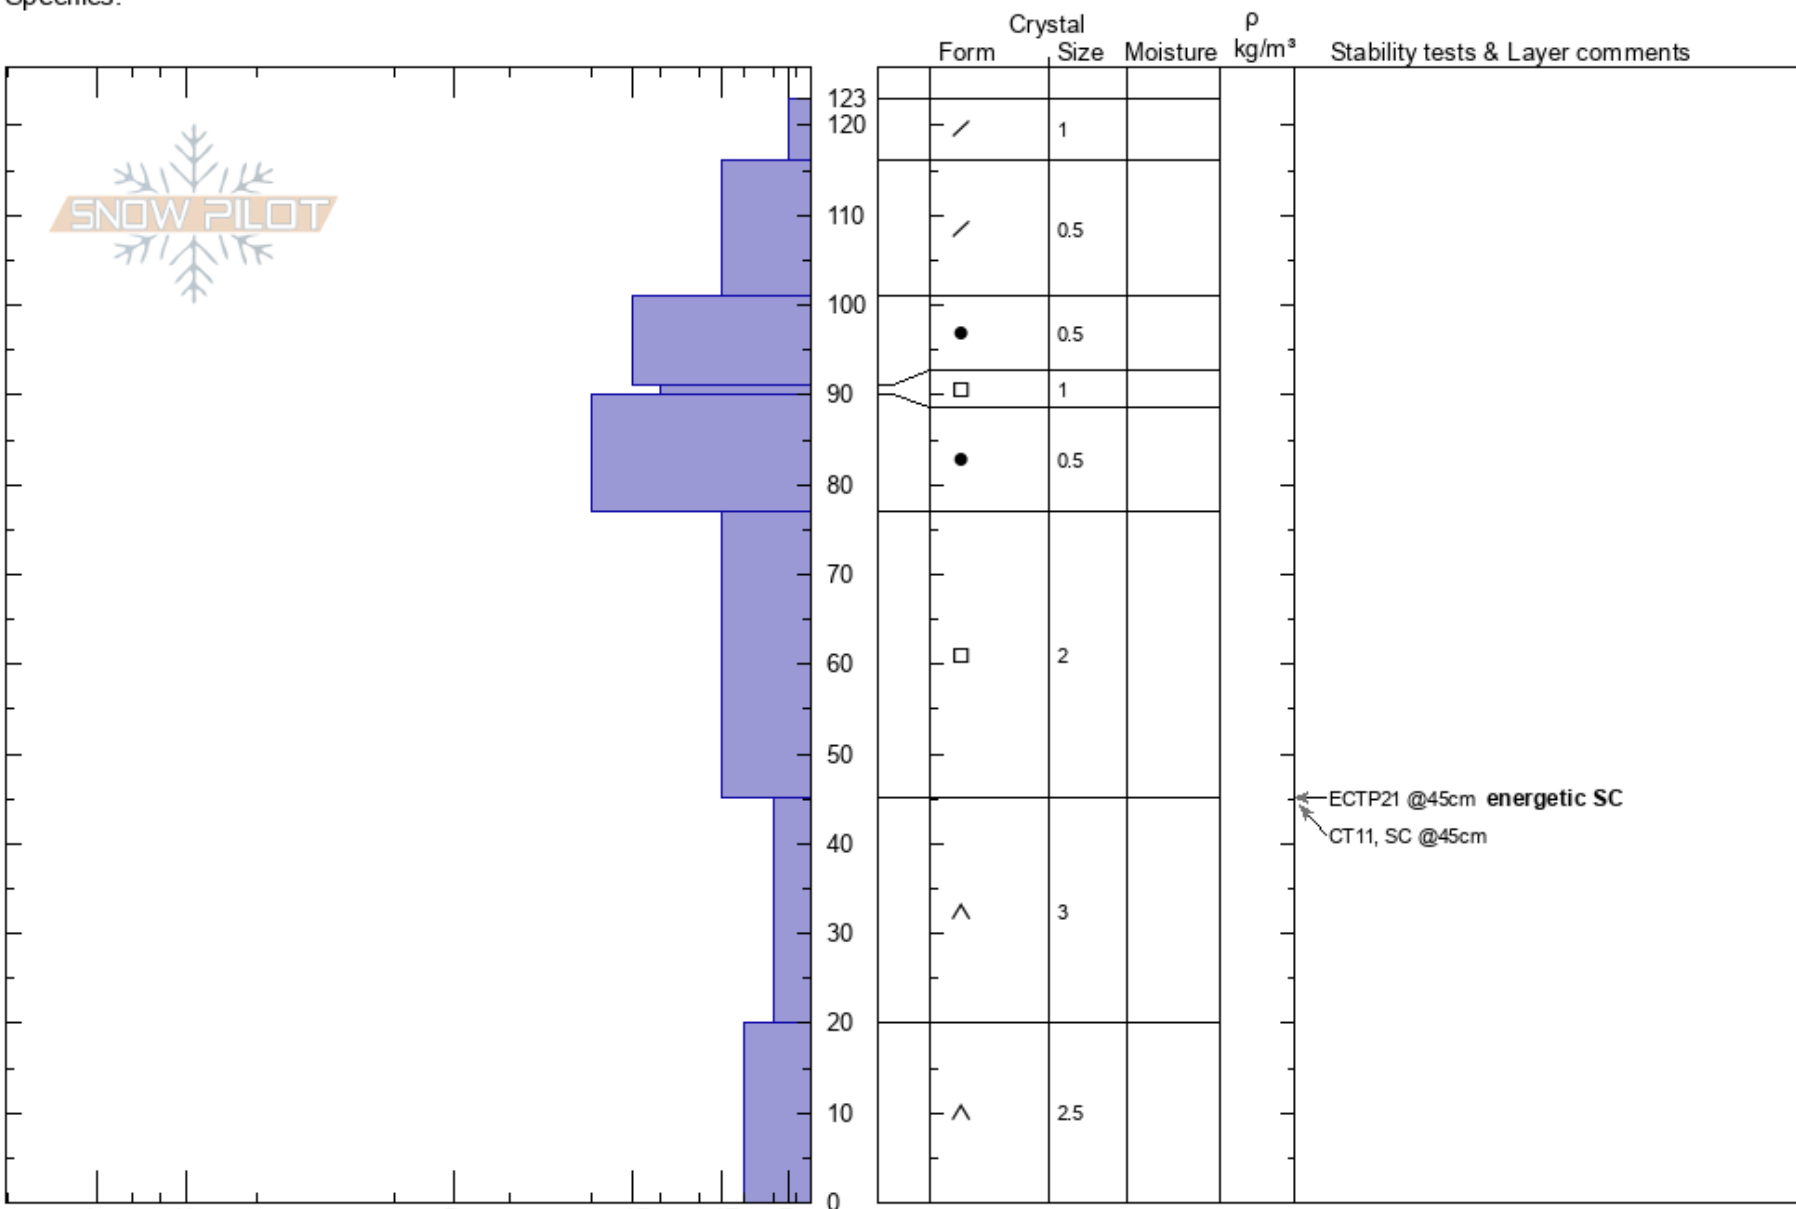
Layer Notes:  
 HS: 123  
 PF: 100 45-20cm: Problematic layer  
 PS: 30

Notes: With Ann Mellick. Pit is an example of an emerging and evolving persistent weak layer. Some northeast aspects at all elevations are shallow. Where HS is around 120cm the lower half is 2mm facets mid pack and 3mm depth hoar. This location has a small, isolated slab on top. The slab is made up of multiple snow and wind events, now settled into the top 40cm. ECTP 21 @ 45 and CT 11 SC at 45 suggest that where this structure exists, stability is poor. So far this is still isolated as many of these shallow areas just dont have much of a slab on top. If you find one you could pop out a little pocket now but more concerning will be once we get the next couple storms adding more load and slab.
