Mill Creek-Red Mt Pass  
San Juan Range  
CO  
Elevation: 11388 ft  
Aspect: N  
Specifics: Collapsing, localized; Cracking; Recent avalanche activity on similar slopes

Bill Nalli  
11/30/2019 - 1:30pm  
Co-ord: 37.86879N, -107.73414W  
Slope Angle: 33°  
Wind Loading: previous

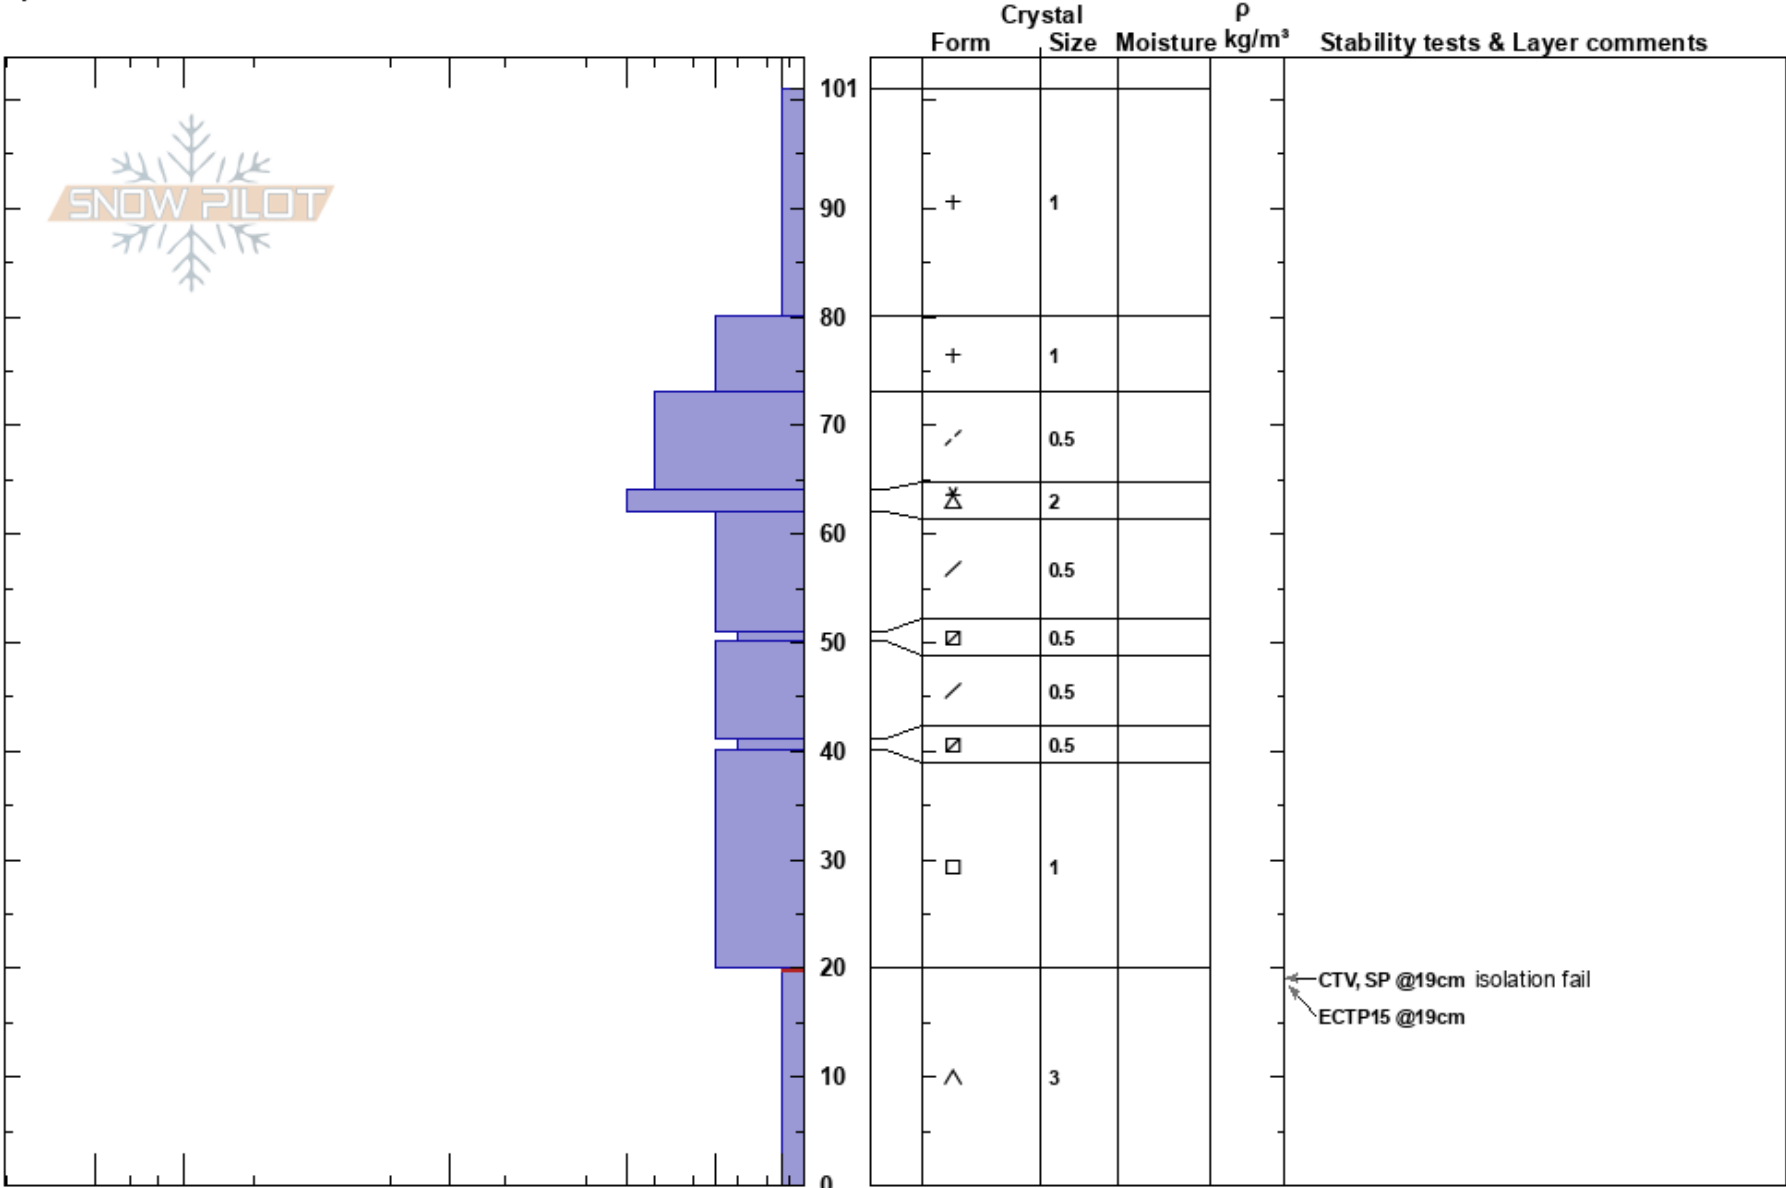
HS: 101  
PF: 100  
PS: 40  
20-0cm: Problematic layer

**Notes:** Suspect test slope failed after I removed one ski and boot penetrated to ground. Large collapse propagated entire slope back onto 20 deg slope at ridgeline. Stability tests confirmed instability even after slope collapsed. Representative of all NW-N-E aspects near and above treeline where very weak facets exist at the ground.
