Esja19\_12\_13

Southwest corner

Iceland

13/12/2019 - 12:00

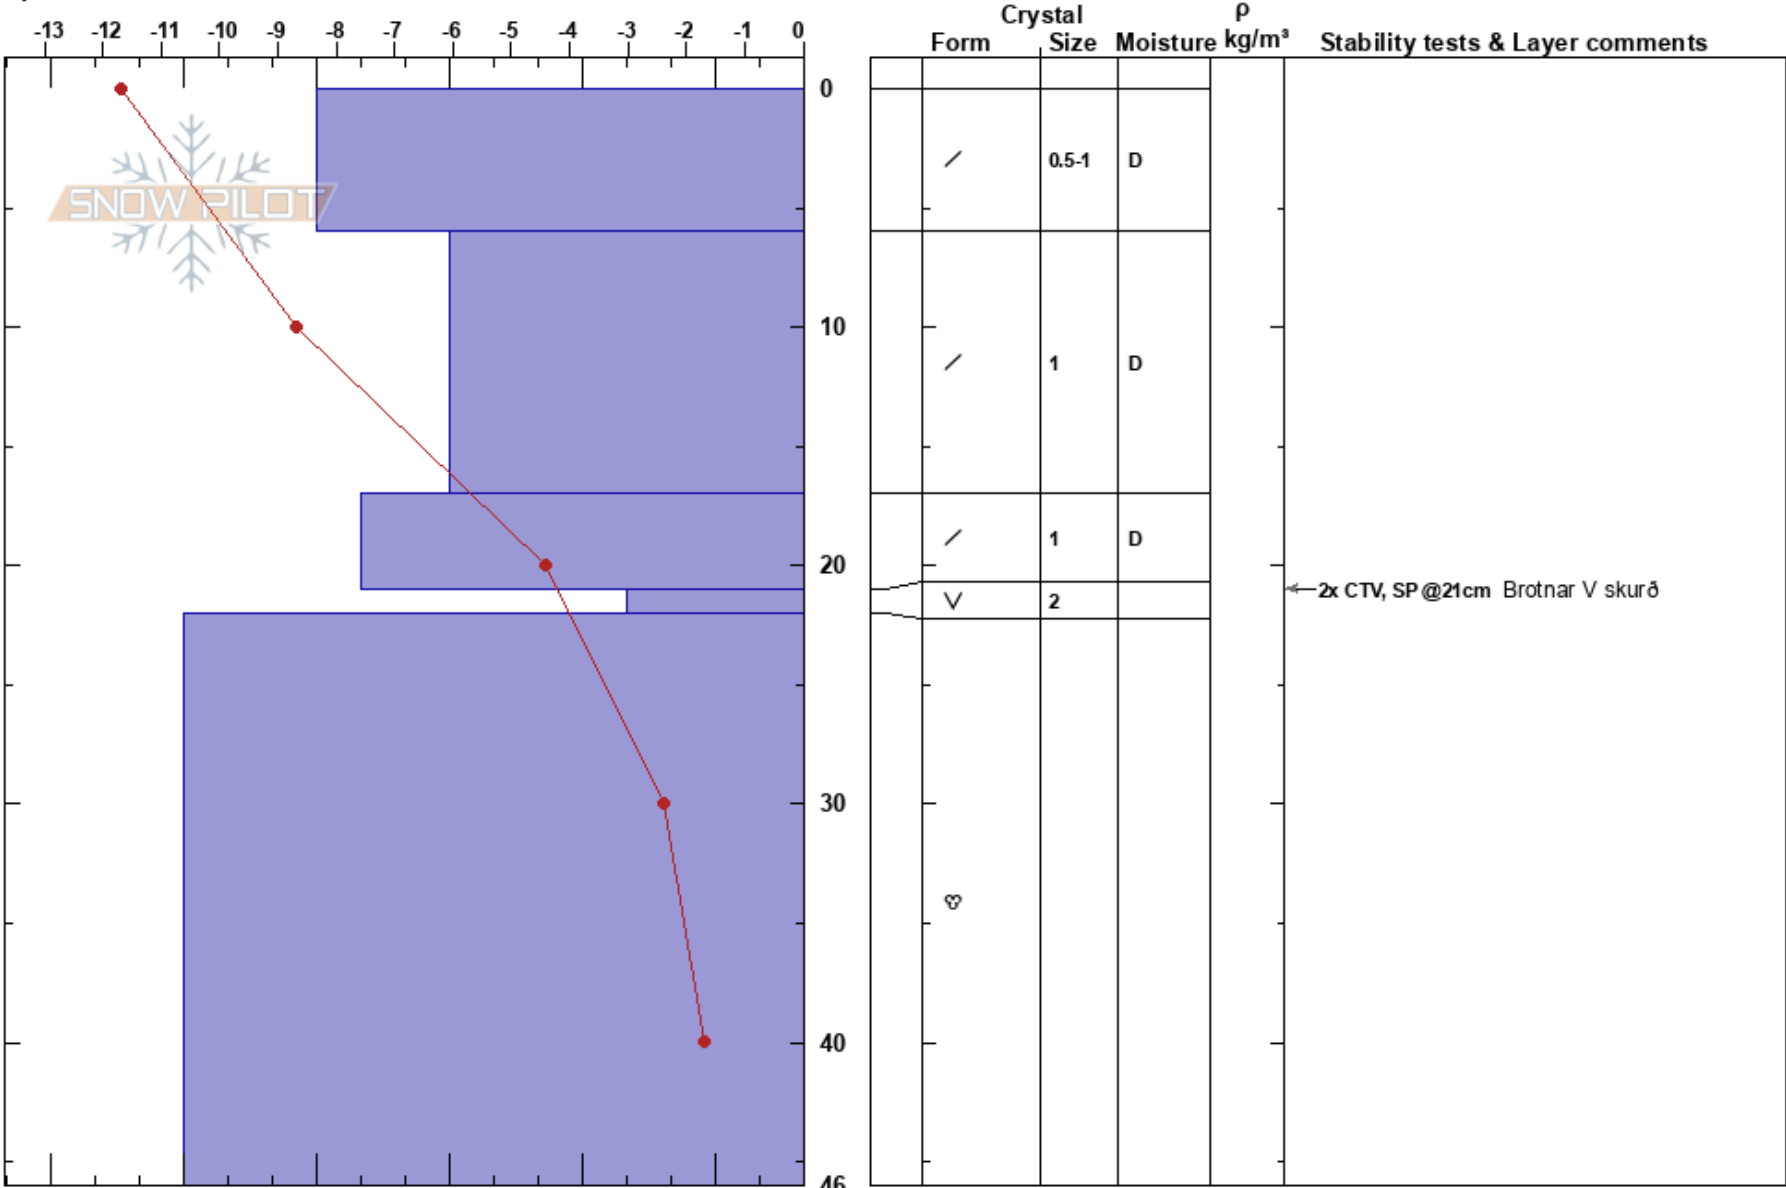
Specifics: Cracking; Recent avalanche activity on similar slopes; Poor pit location

21-22cm: Problematic layer

Notes: Lítil snjór. Gryfja tekin þar sem skafrenningur hafði safnast ofná eldir snjó. Tekið við í Rauðhólum í Esju.
