Irene's Cement Creek  
San Juan Range  
CO  
Elevation: 12010 ft  
Aspect: NE  
Specifics:

Bill Nalli  
03/03/2020 - 12:00pm  
Co-ord: 37.83338N, -107.69686W  
Slope Angle: 34°  
Wind Loading: yes

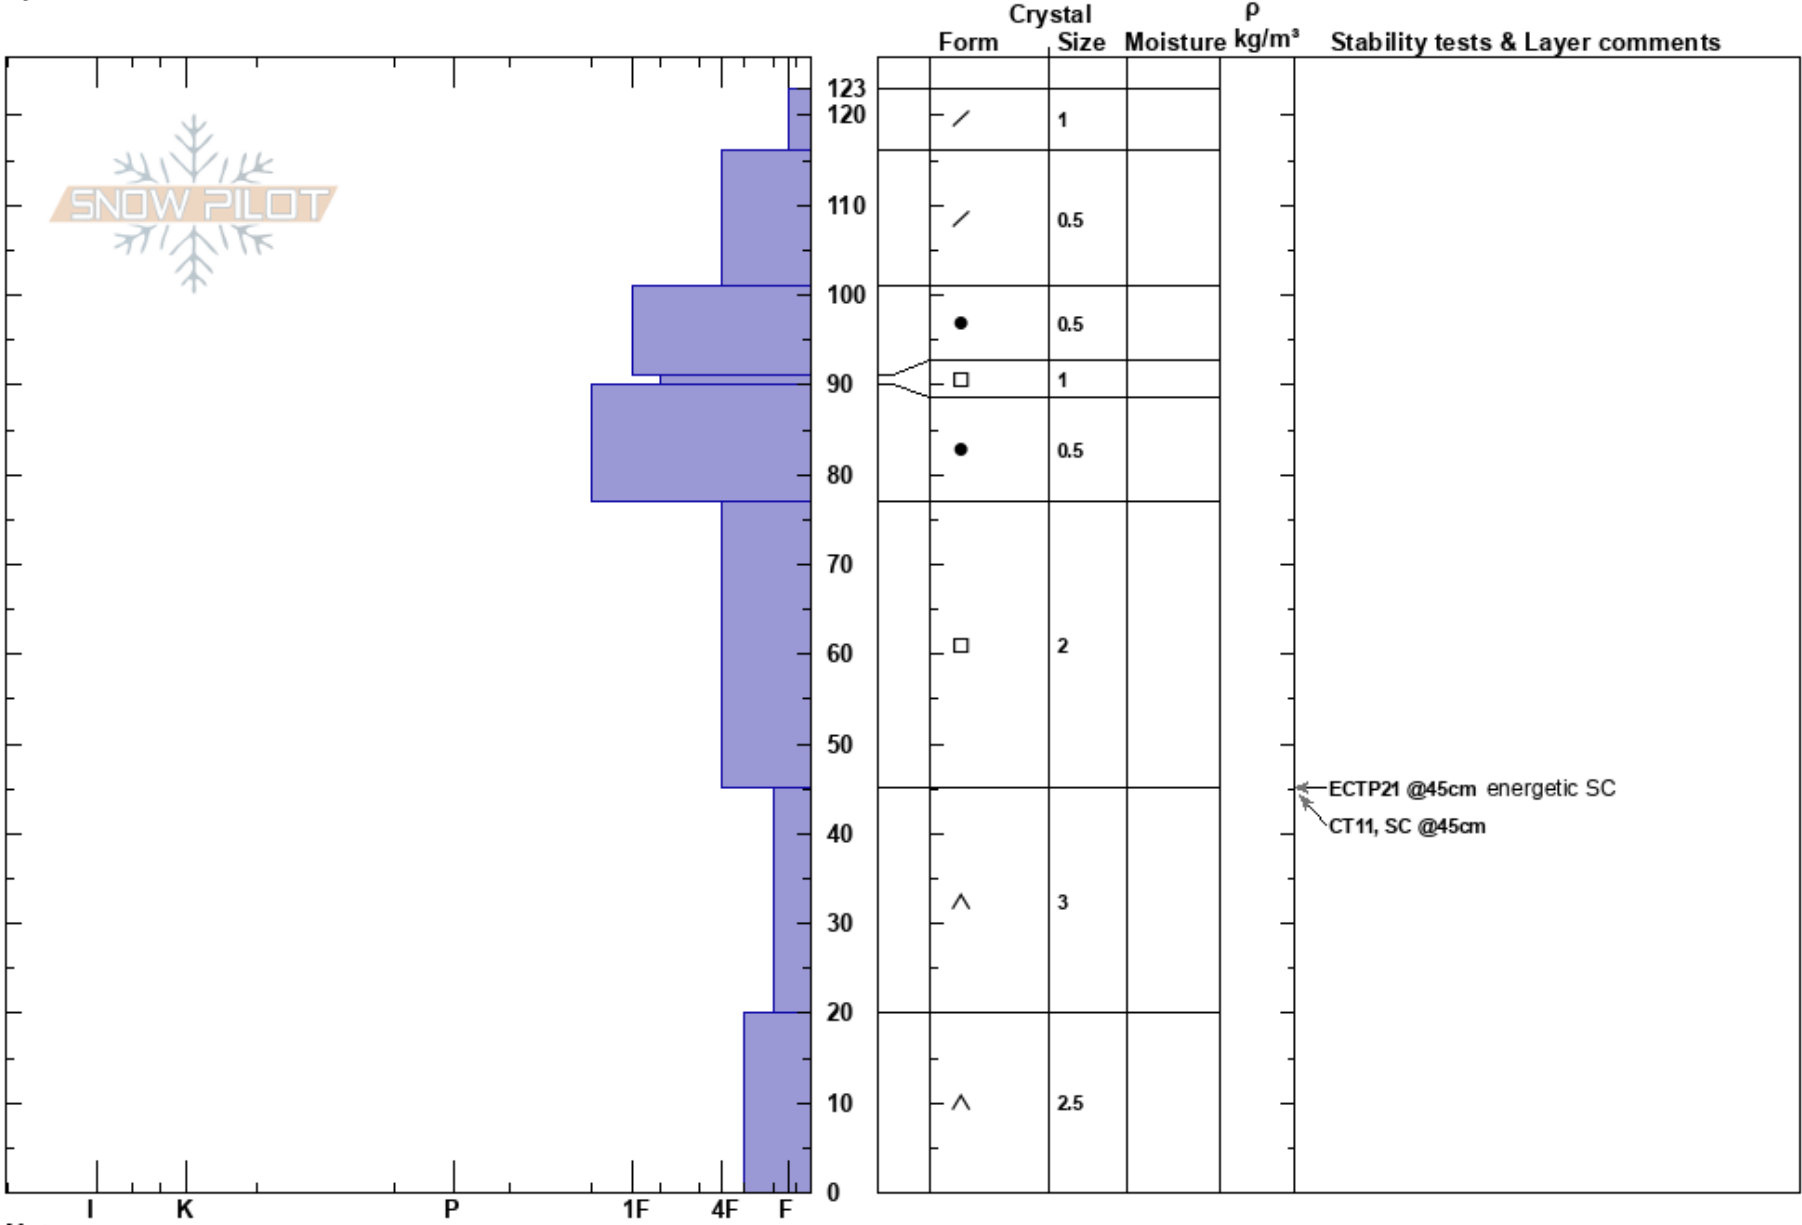
HS: 123  
PF: 100 45-20cm: Problematic layer  
PS: 30

**Notes:** With Ann Mellick. Pit is an example of an emerging and evolving persistent weak layer. Some northeast aspects at all elevations are shallow. Where HS is around 120cm the lower half is 2mm facets mid pack and 3mm depth hoar. This location has a small, isolated slab on top. The slab is made up of multiple snow and wind events, now settled into the top 40cm. ECTP 21 @ 45 and CT 11 SC at 45 suggest that where this structure exists, stability is poor. So far this is still isolated as many of these shallow areas just dont have much of a slab on top. If you find one you could pop out a little pocket now but more concerning will be once we get the next couple storms adding more load and slab.
