Ampi Drainage  
 Turoa  
 New Zealand  
**Elevation:** 1800 m  
**Aspect:** SE

Andy Corkill  
 26/08/2023 - 10:00  
**Co-ord:** -39.30542S, 175.53901E  
**Slope Angle:** 35°  
**Wind Loading:**

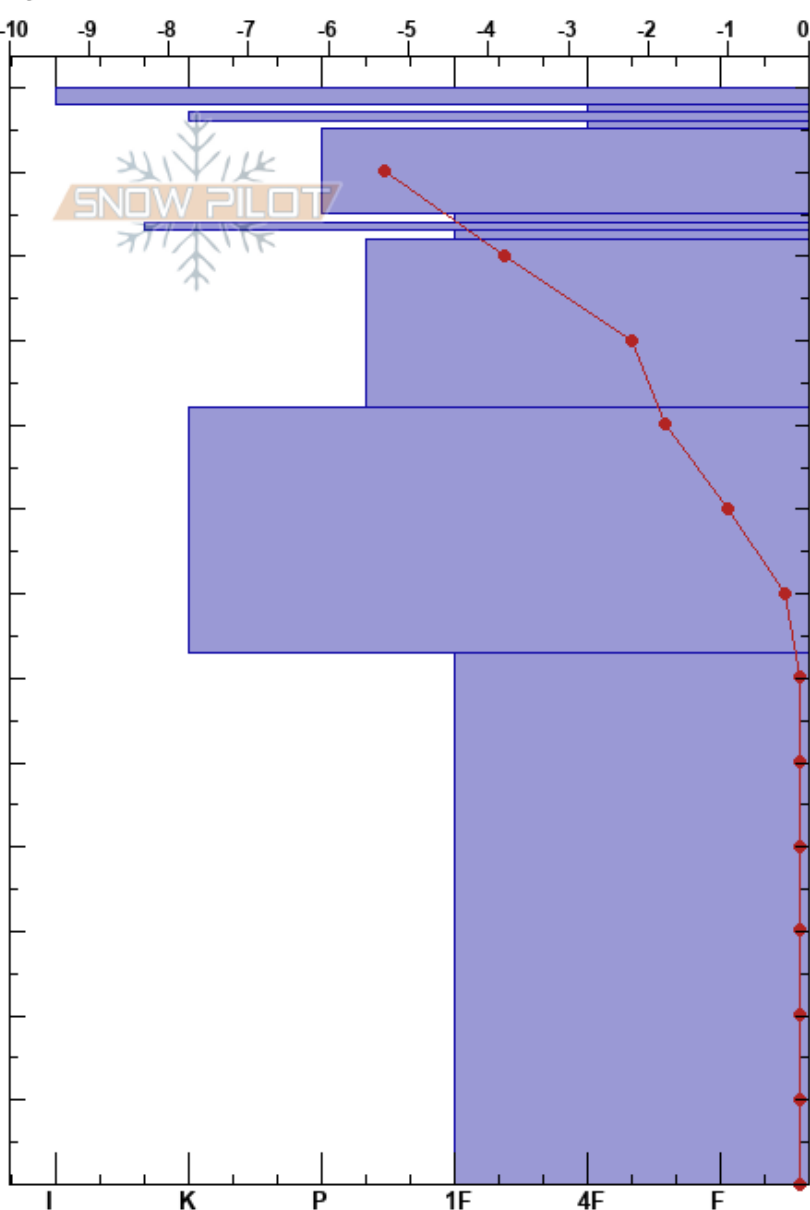
**HS:** 130  
**PF:** 0  
**PS:** 0  
**Layer Notes:**  
 130-128cm: Unbreakable to boot  
 113-112cm: Problematic layer  
 92-63cm: Multiple IFi/MF  
 63-0cm: moist to ground

Depth (cm)	Crystal		Moisture	$\rho$ kg/m <sup>3</sup>	Stability tests & Layer comments
	Form	Size			
130	▽				
128	■		D		130-128cm: Unbreakable to boot
120	□	1-3	D		
113	⊙				CT11, RP @113cm On FC CT18, RP @113cm On FC
112	□	1-3	D		
110	⊕		D		
100	□	1-2	D		
92	■		D		CT25, BRK @92cm CT22, BRK @92cm
63	○ (■)		D		92-63cm: Multiple IFi/MF
63-0	⊕		M		63-0cm: moist to ground

**Notes:** Tracking FC layers.
