Happy Face Crown Wall  
 Elk Mountains  
 CO  
**Elevation:** 10960 ft  
**Aspect:** 6°

Debbie Kelly  
 02/14/2018 - 10:45am  
**Co-ord:** 39.13560N, -106.80685W  
**Slope Angle:** 30°  
**Wind Loading:** previous

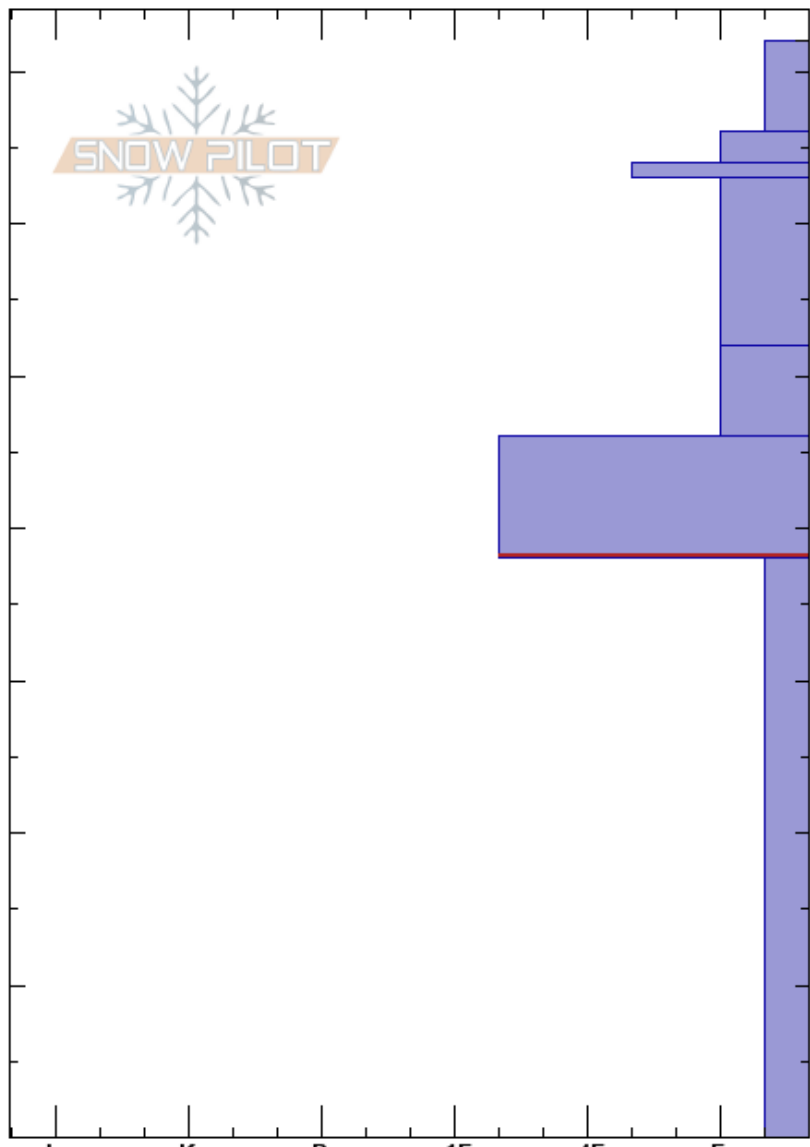
**HS:** 72  
**Layer Notes:**  
 46-38cm: bed surface at bottom  
 46-38cm: Problematic layer  
 38-0cm: Not to ground

**Specifics:** Pit is adjacent to avalanche: crown; Cracking; Recent avalanche activity on similar slopes; Recent avalanche activity on different slopes

Crystal Form	Size	Moisture	$\rho$ kg/m <sup>3</sup>	Stability tests & Layer comments
+				
+				
+ ( / )				
/				
•	0.3			
□	2			46-38cm: bed surface at bottom
□ ( ^ )	4-6			38-0cm: Not to ground

**Notes:** Crown Wall profile post R3, D2.5 (13 Feb); widespread cracking observed: Obs: Steve Schreiber, Debbie Kelly
