West Lime Cr 1/13/17  
San Juan Range  
CO  
Elevation: 10000 ft  
Aspect: 70°  
Specifics: Recent avalanche activity on different slopes

Susan Hale  
01/13/2017 - 1:00pm  
Co-ord:  
Slope Angle:  
Wind Loading: previous

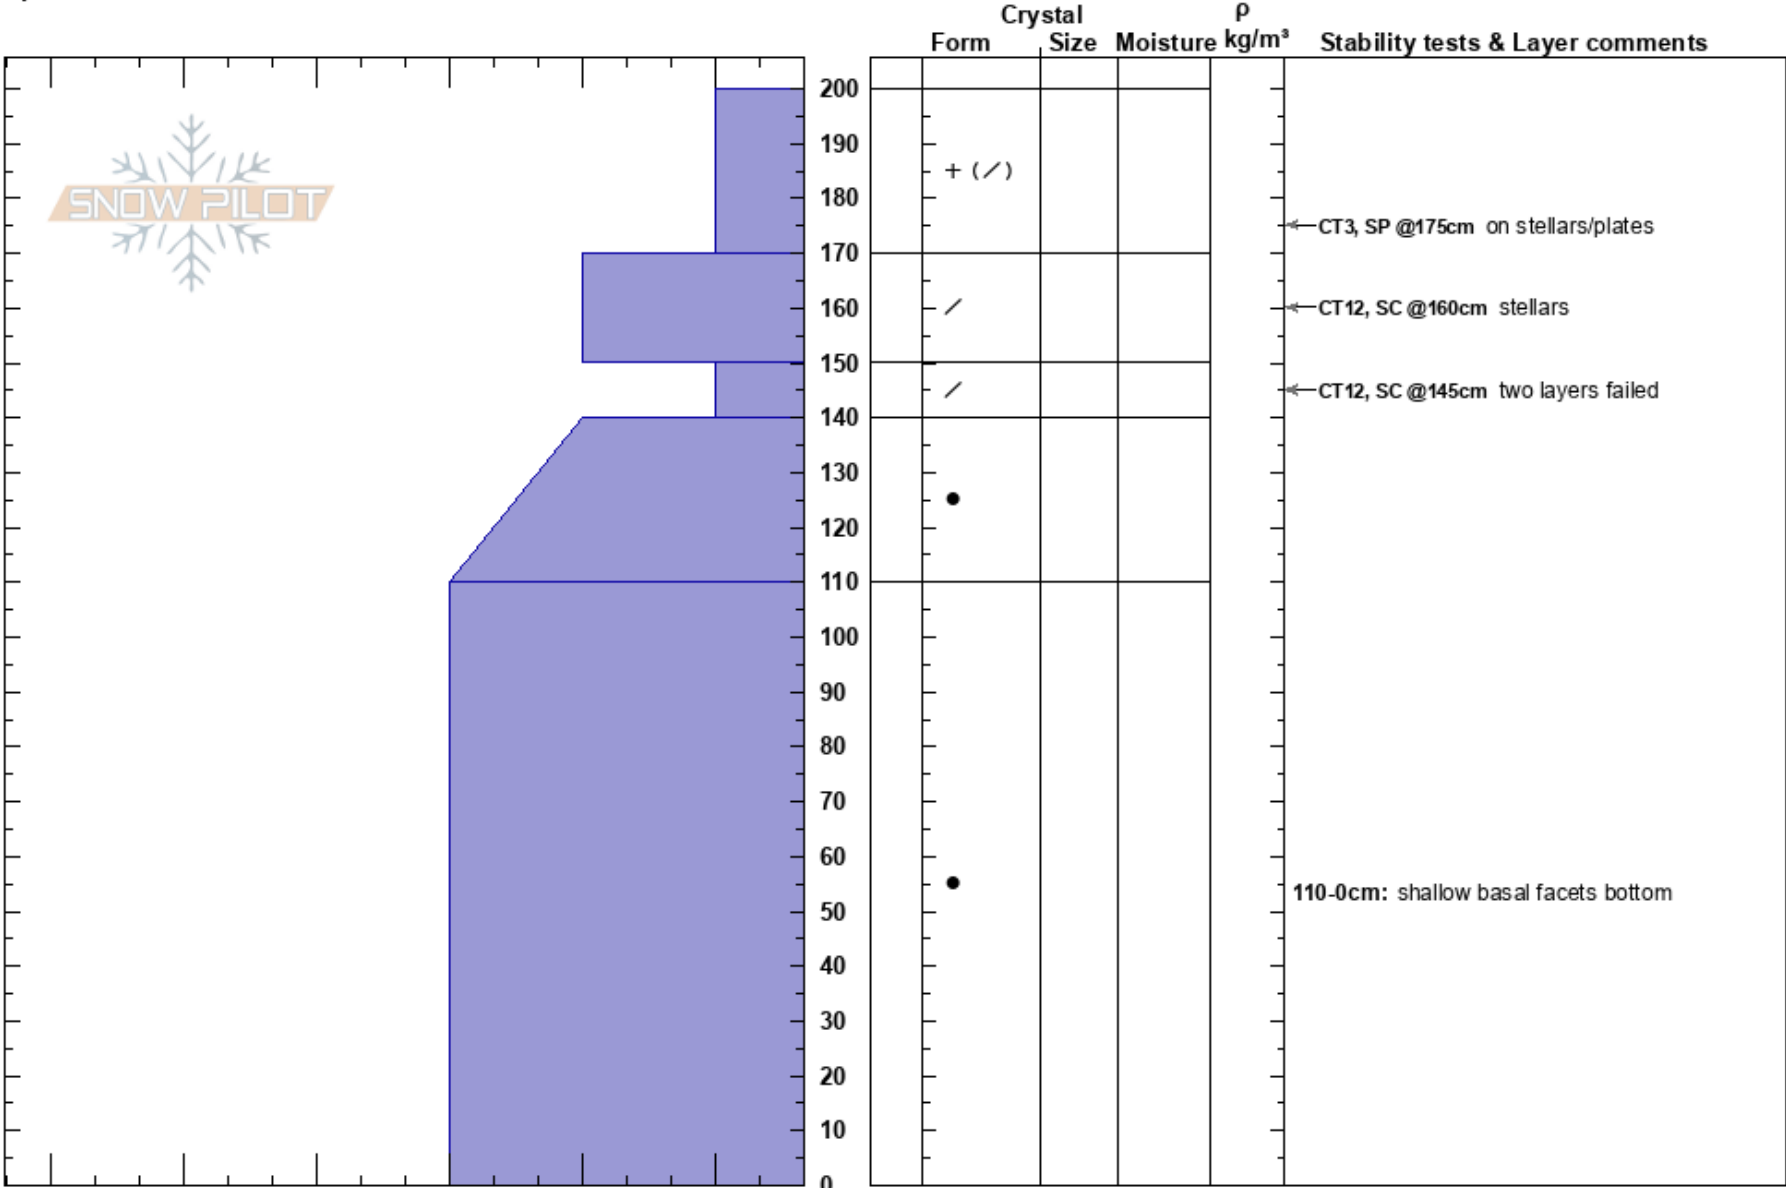
Layer Notes:

HS:200  
PF: 40  
150-140cm: Problematic layer  
110-0cm: shallow basal facets bottom

**Notes:** This is a benched but very lengthy highway avalanche path - a long stretch of hwy exposure. It is generally a planar slope but with undulations that cross load with southerly winds. This path has gained unusual volume this winter. The mid-pack is stout. Feel the upper-most instabilities will heal with time. This pit confirms that any future issues with this path will be with mostly storm snow
