West Lime Cr 1/13/17

San Juan Range

01/13/2017 - 1:00pm

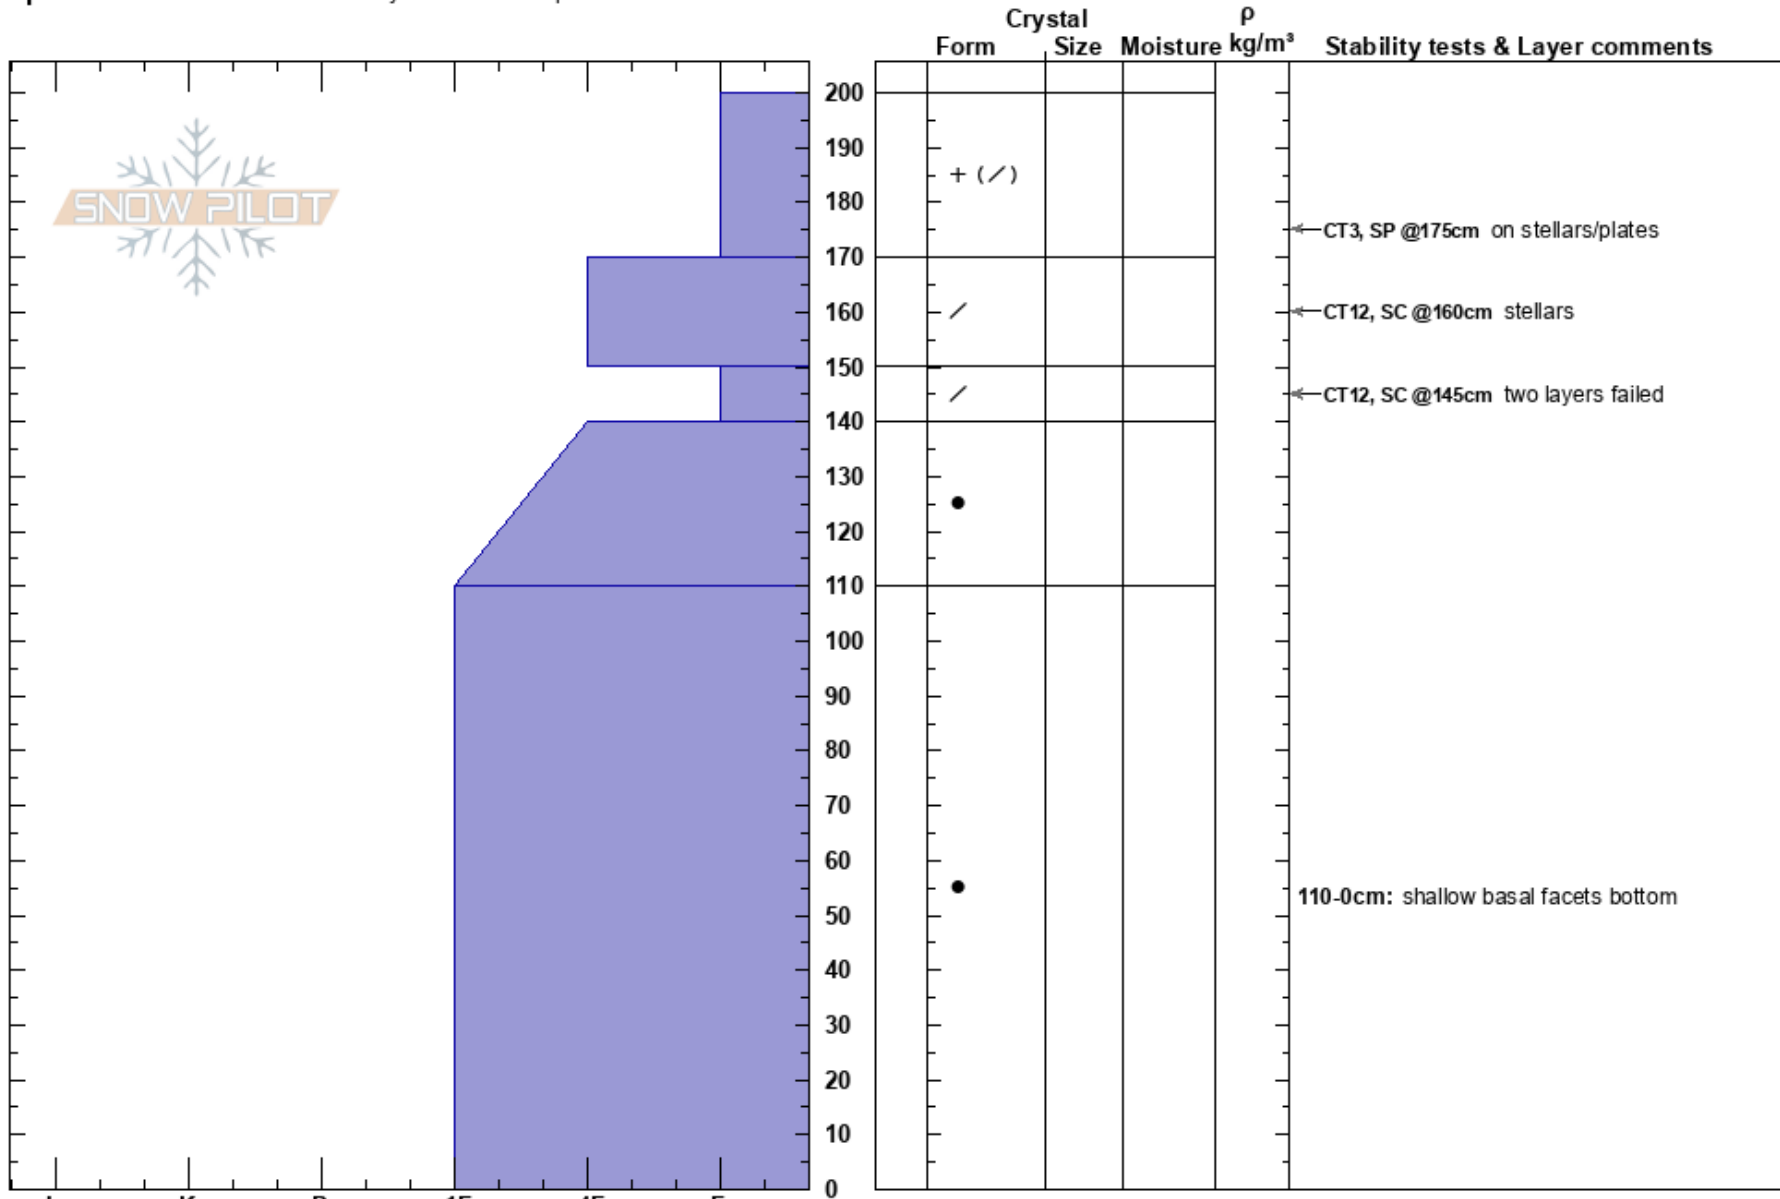
150-140cm: Problematic layer

110-0cm: shallow basal facets bottom

**Notes:** This is a benched but very lengthy highway avalanche path - a long stretch of hwy exposure. It is generally a planar slope but with undulations that cross load with southerly winds. This path has gained unusual volume this winter. The mid-pack is stout. Feel the upper-most instabilities will heal with time. This pit confirms that any future issues with this path will be with mostly storm snow
